RESI - application examples

- RESI case study's

RESI case study's

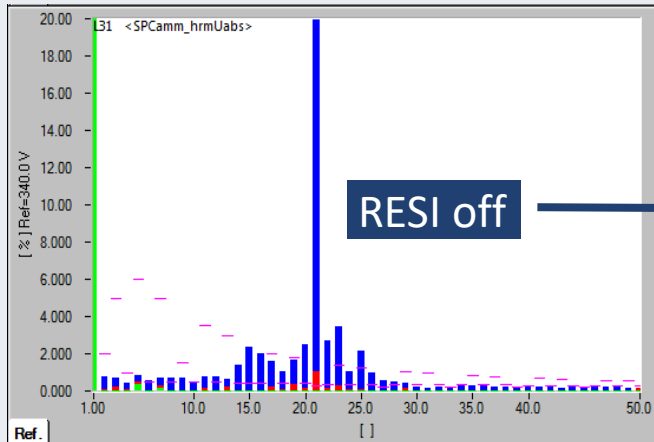
- 1st case: Solar park (~30 MWp)
 - 11 solar converters (1,8 MWp) feeding by one 2 MVA transformer

Resonance at around 1050 Hz
Voltage levels up to 20 %

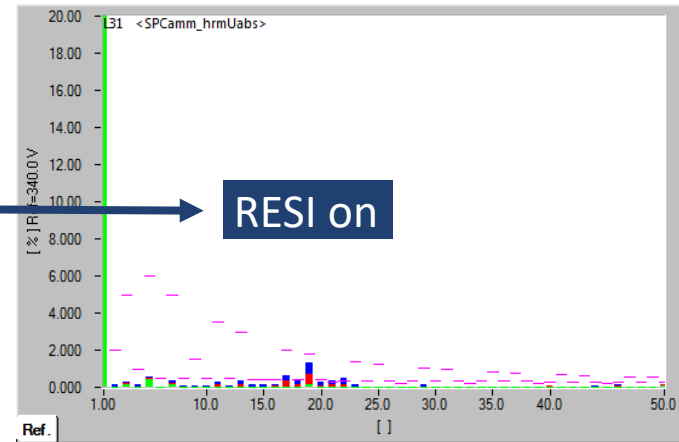
Resonance eliminated

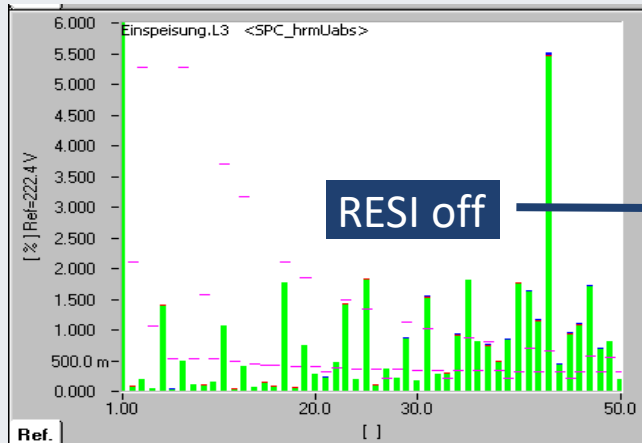
- 2nd case: Power supply units (900 kW) for particle accelerator
 - Problem: blackouts and damages of power supplies

Disturbances > 1 kHz
Voltage levels up to 5,5 %

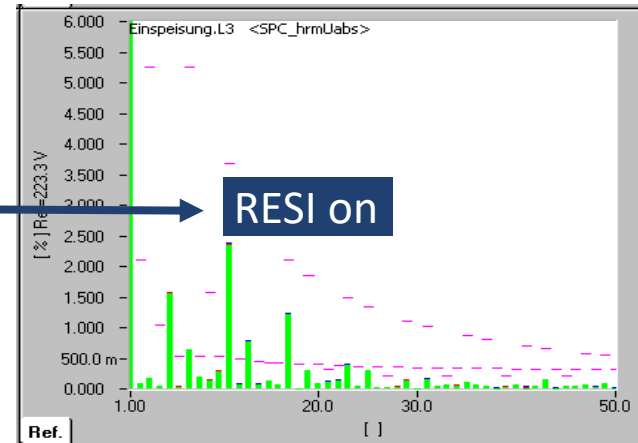
No more higher frequency's

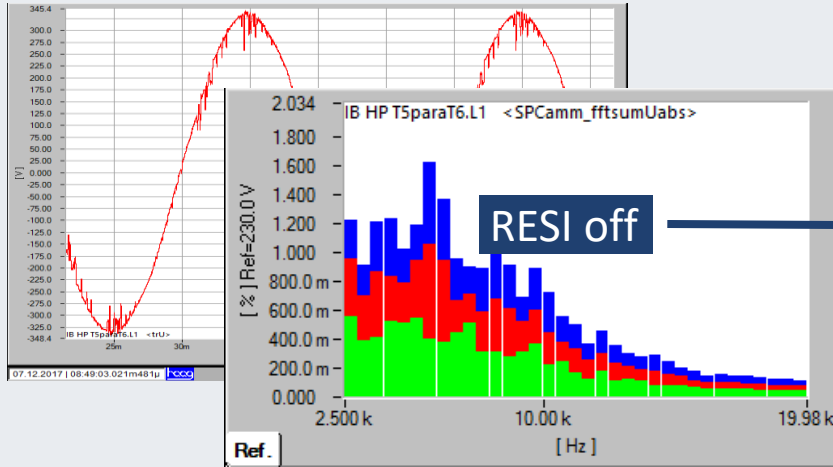
- 3rd case: Batterie factory
 - Problem: failures of frequency inverters

Disturbances > 2 kHz
 Voltage levels up to 1,7 %

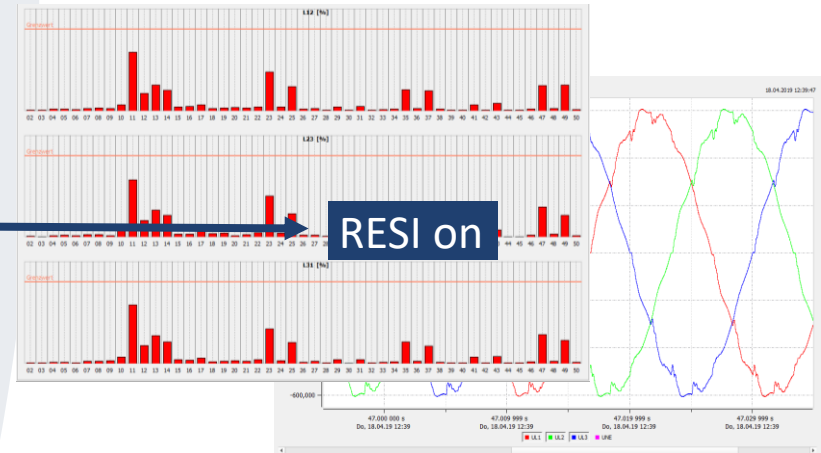
- 4th case: Power plant with 15 MW MV DC-water pump
 - Problem: failures of frequency inverters in 690 V grids (3,15 MVA)

Commutations notches
Resonance
High (supra-) harmonics

Reduction of the notches
Elimination of the resonance
Reduced voltage levels

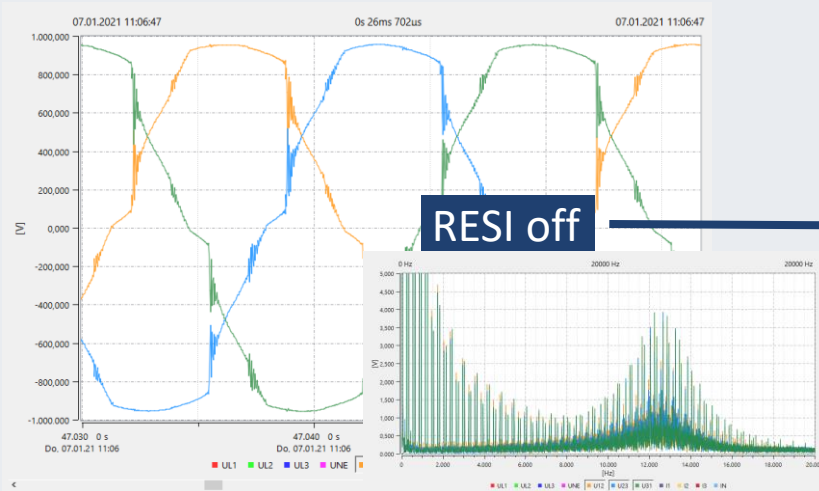
- 5th case: Factory for insulating material
 - Problem: failures of frequency inverters in 690 V grid

Resonance triggered by
Commutation notches
High supraharmonics

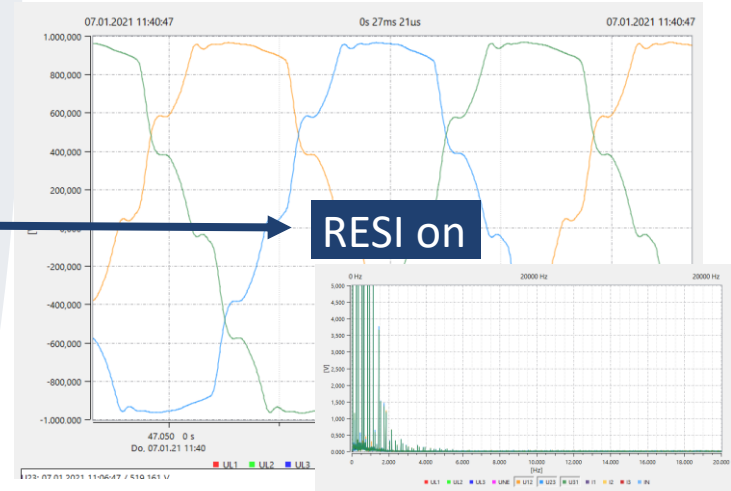
Elimination of the resonance
Reduced supraharmonics

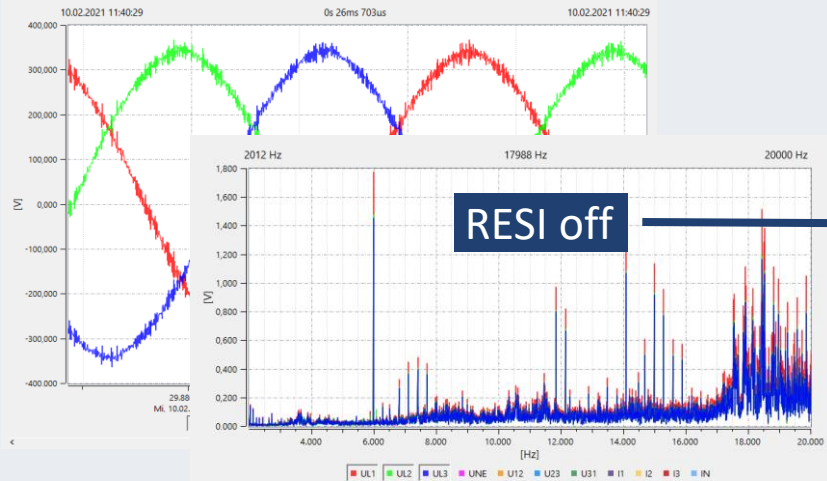
RESI off

- 6th case: Waste power plant in Austria
 - Problem: new active front end crane drives

Different switching frequency's

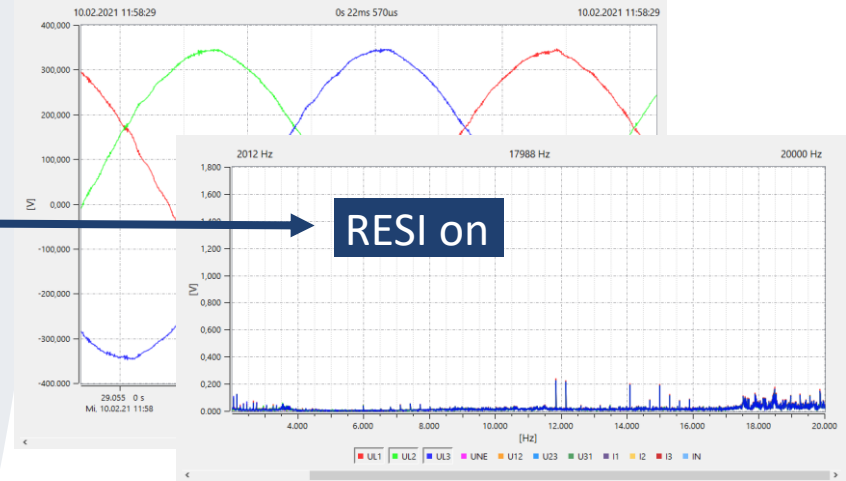
RESI on

Reduction of the voltage levels
